## Stormwater Division

### MEMORANDUM

**DATE:** March 4, 2010  
**TO:** Michael J. Gillis, Virginia Correctional Enterprises Document Management Services  
**FROM:** Jo Anna Ripley, Stormwater  
**PO:** 270712  
**RE:** Files Approved for Scanning

WATERSHED	PC	MAINTENANCE PLAN	No	CTRL STRUC DESC	CMP Riser
BMP ID NO	107	SITE AREA acre	521.7	CTRL STRUC SIZE inches	36
PLAN NO	SP-61-98	LAND USE	Public Park	OTLT BARREL DESC	CMP Barrel
TAX PARCEL	(32-01)(01-12)	old BMP TYP	Wet Pond	OTLT BARREL SIZE inch	18
PIN NO	3210100012	JCC BMP CODE		EMERG SPILLWAY	No
CONSTRUCTION DATE		POINT VALUE		DESIGN HW ELEV	
PROJECT NAME	Warhill Tract-JCC Sports Complex			PERM POOL ELEV	
FACILITY LOCATION	Wet Pond #1 (East BBF # 4)			2-YR OUTFLOW cfs	0.00
CITY-STATE	Williamsburg, Va. 23188	SVC DRAIN AREA acres		10-YR OUTFLOW cfs	0.00
CURRENT OWNER	James City County, Virginia			REC DRAWING	No
OWNER ADDRESS	101 Mounts Bay Road				
OWNER ADDRESS 2	P.O. Box 8784	SERVICE AREA DESCR	Baseball Fields & Woods		
CITY-STATE-ZIP CODE	Williamsburg, Va. 23187	IMPERV AREA acres	0	CONSTR CERTI	No
OWNER PHONE		RECV STREAM	UT of Longhill Swamp		
MAINT AGREEMENT	No	EXT DET-WQ-CTRL	Yes	LAST INSP DATE	10/27/2000

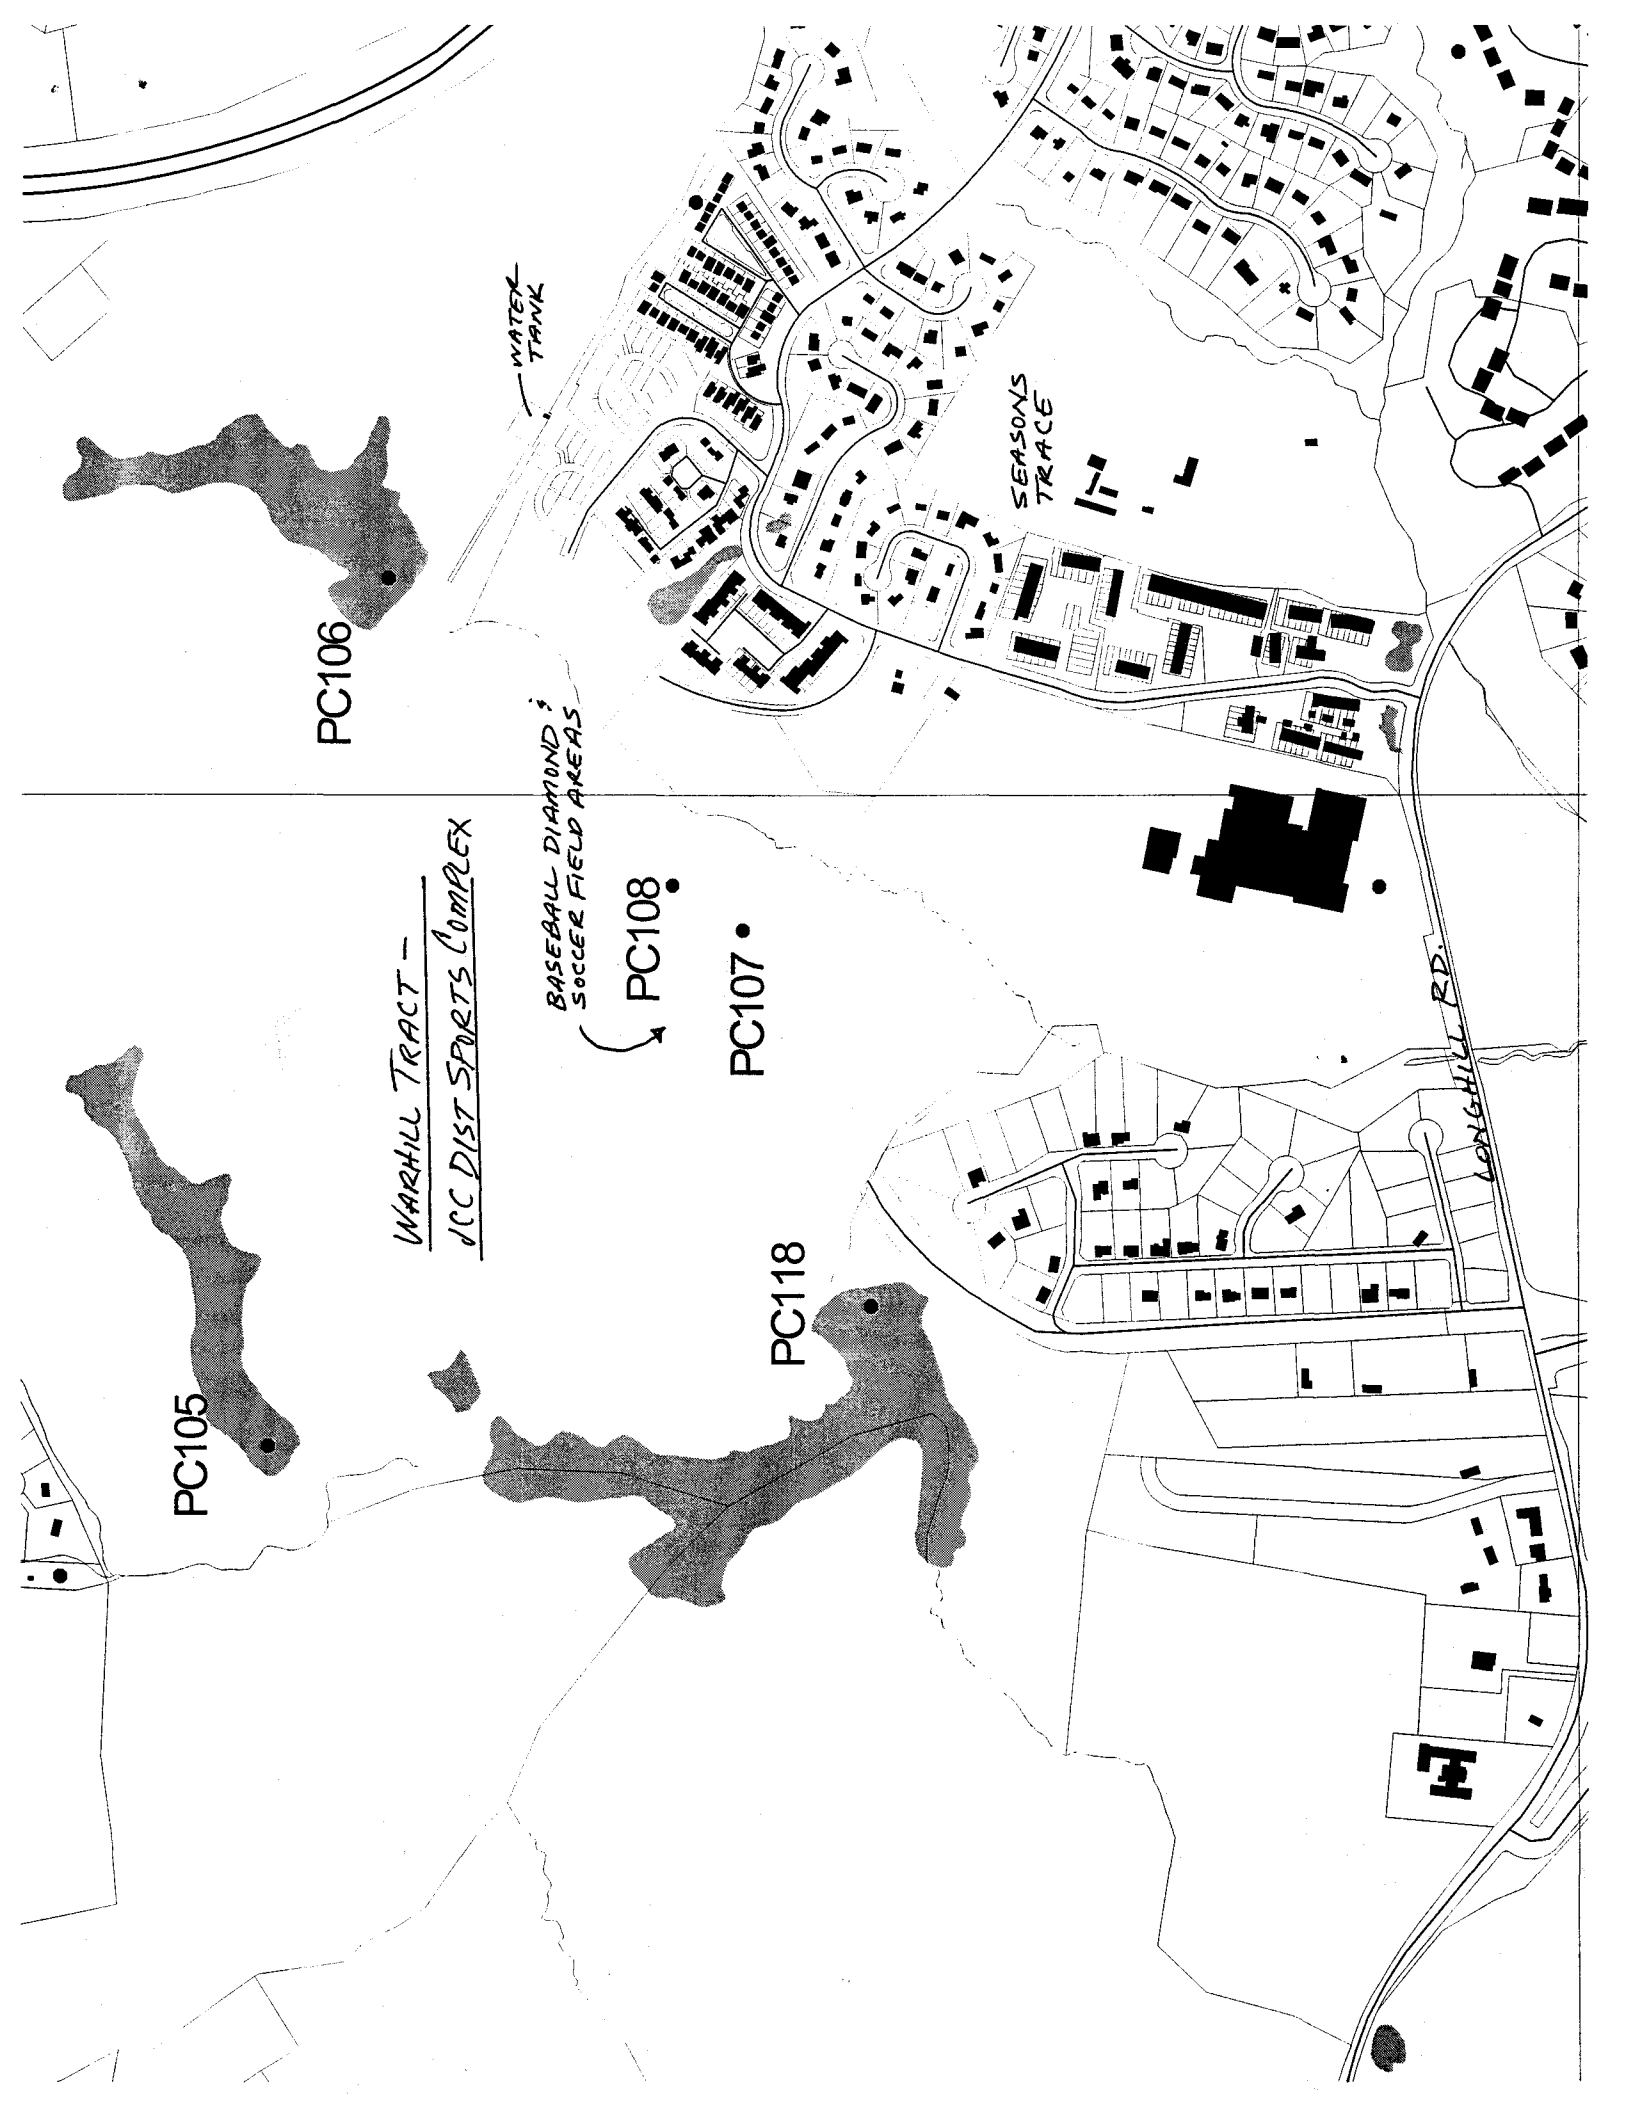
EMERG ACTION PLAN	No	WTR QUAL VOL acre-ft		INTERNAL RATING	3
		CHAN PROT CTRL	No	MISC/COMMENTS	SB 1. New Wet Pond east of first BB Diamond. Sta. 47+50, 850' RL.
		CHAN PROT VOL acre-ft	0		
		SW/FLOOD CONTROL	Yes		
		GEOTECH REPORT	No

WARHILL TRACT -  
JCC DIST SPORTS COMPLEX

BASEBALL DIAMOND &  
SOCCER FIELD AREAS
